DEPARTMENT OF TRANSPORTATION

Contract #: 04-0120F4Cty: SF/ALA Rte: 80 PM: 13.2/13.9File #: 69.28**WELDING INSPECTION REPORT****Resident Engineer:**Siegenthaler, Peter**Address:** 333 Burma Road**City:** Oakland, CA 94607**Report No:** WIR-022254**Date Inspected:** 28-Mar-2011**Project Name:** SAS Superstructure**OSM Arrival Time:** 700**Prime Contractor:** American Bridge/Fluor Enterprises, a JV**OSM Departure Time:** 1900**Contractor:** Zhenhua Port Machinery Company, Ltd (ZPMC), Changxing Island **Location:** Shanghai, China**CWI Name:** An Qing Xiang**CWI Present:** Yes No**Inspected CWI report:** Yes No N/A**Rod Oven in Use:** Yes No N/A**Electrode to specification:** Yes No N/A**Weld Procedures Followed:** Yes No N/A**Qualified Welders:** Yes No N/A**Verified Joint Fit-up:** Yes No N/A**Approved Drawings:** Yes No N/A**Approved WPS:** Yes No N/A**Delayed / Cancelled:** Yes No N/A**Bridge No:** 34-0006**Component:** OBG**Summary of Items Observed:**

BAY 14, OBG 13BW (NWIT # 08652)

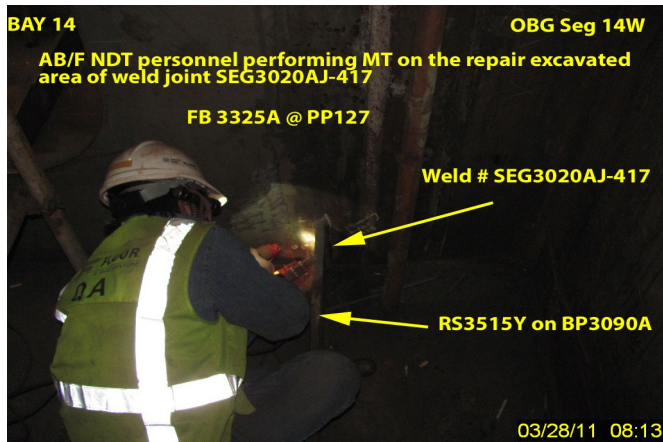
During random in process inspection this QA inspector observed that AB/F NDT personnel Mr. Lin Ming was performing Magnetic Particle Testing (MT) on the repair excavated area of the weld joint SEG3020AJ-417 Joining I-rib stiffener RS3515Y on Bottom Plate (BP) 3090A to Floor Beam (FB) 3325A at Panel Point (PP) 127. Attached photograph provide additional details.
